Town of Middleboro - Old Police Station 99 North Main Street Middleboro, MA 02346

HVAC Assessment

December 20, 2018

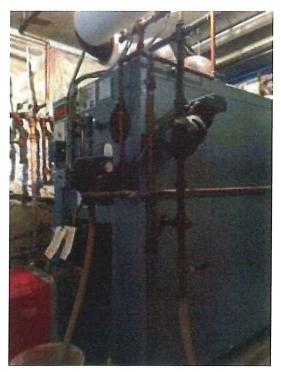
The original boiler in the building was retrofit with a natural gas fired Smith manufactured steam boiler. (See **Figure 1**) This boiler is designed for 1,089,000 BTU/HR with an efficiency of 80% and supplies steam to throughout the building. (See **Figure 2**) The boiler is controlled by a Taco SR 501 that turns the boiler on/off. It was unclear during our investigation whether the boiler is controlled based on outside air temperature or inside space temperature. Overall, the boiler appears to be in good operating and visual condition. It is estimated to be about 10 years old and per American Society of Heating, Refrigeration, and Air Conditioning Engineers (ASHRAE) similar cast iron boilers have a life cycle of 30 years when maintained properly.

Figure 1 – Smith steam boiler located in basement level boiler room.

1. Do not turn off the boiler system

If the boiler system is turned off, drained down, and abandoned in place, the existing heating system will never be in working capacity again without a complete overhaul. On top of that, the interior conditions of the building will rapidly deteriorate. It is recommended to maintain minimum temperature in the space during heating season.

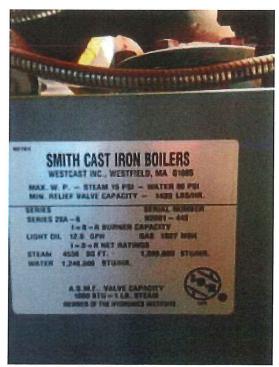
Figure 2 – Smith steam boiler nameplate.

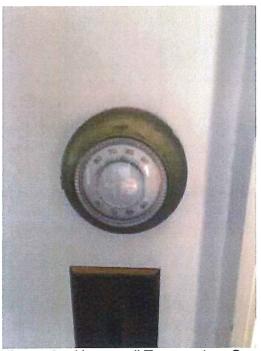
Two pipe steam radiators are controlled by temperature sensors that send a signal to zone valves regulating steam flow through radiators. Temperature sensors in the space are original Honeywell mechanical non-programmable thermostats (See **Figure 3**) with no set back capabilities. The zone valve pictured in **Figure 4** is dated with an install date of 1995. It was mentioned that sometimes the heat does not turn on which signifies either a failing temperature sensor or bad valve actuators on zone valves. The temperature sensors and zone valves are the biggest risk for building control.

Figure 3 – Honeywell Temperature Sensor.

Thermostats: It is recommended to replace all temperature sensors in the space with battery operated programmable thermostats with scheduling for occupied and unoccupied temperature set back. The building is no longer operated 24/7 and does not need to be heated to comfort temperature 24/7. Spaces that will be occupied should have an occupied set point of 70 degrees and an unoccupied set point of 65 degrees. Spaces that will not be utilized should have a constant temperature set point of 55 degrees to maintain above freezing temperatures. Zoning will have to be investigated.

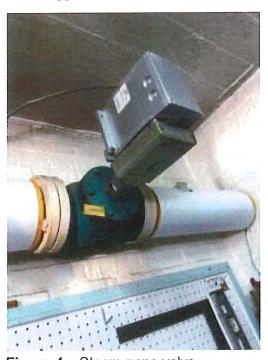
Figure 4 – Steam zone valve.

Valves: Once all temperature sensors are replaced, it should be investigated whether the corresponding zone valve is operating as it should. If valves and actuators are identified as no longer working, they should be replaced to maintain set point temperature of the space.
